THE NUCLEAR THERMAL EFFECTS ON HUMIDITY SATURATED COMPOSITE **MATERIALS**

Rockwell International Corporation Los Angeles Division P.O. Box 92098 Los Angeles, California 90009

February 1979

Final Report for Period December 1977—February 1979

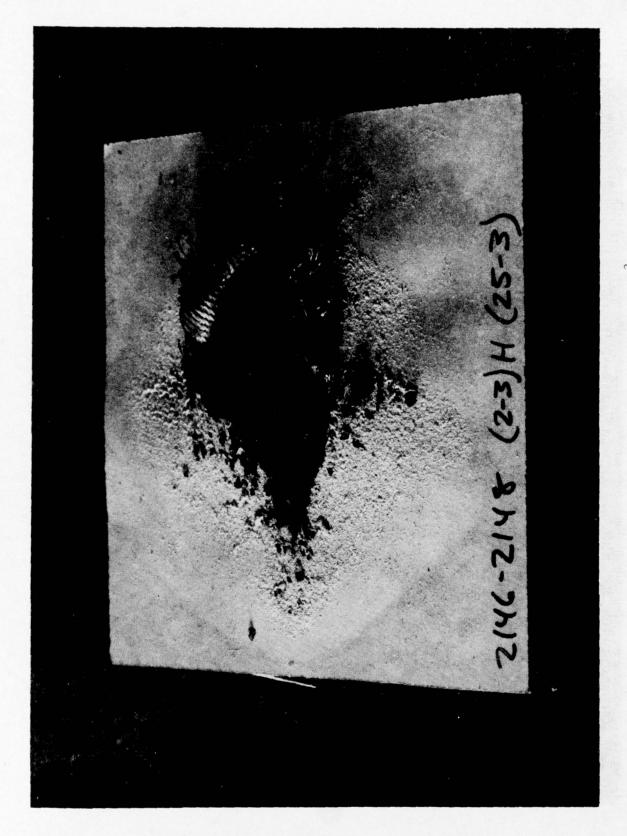
System 2 three-, four-, and five-ply laminates all failed at 25 cal/cm² after only one flash. The failure mechanism was blistering and yellowing of the paint after one shot and a severe interlaminar delamination after two or more flashes. Figure 5 shows a system 2 laminate after three flashes at 25 cal/cm². The six-ply laminates were unaffected by up to five flashes in a dry condition. In a humidity saturated condition, the six-ply laminates were unaffected by one flash but suffered paint discoloration after three flashes and severe paint discoloration and blistering after five flashes. (Figure 6 illustrates the difference between three and five flashes.)

Figure 5. System 2 - three flashes at 25 cal/cm^2 .

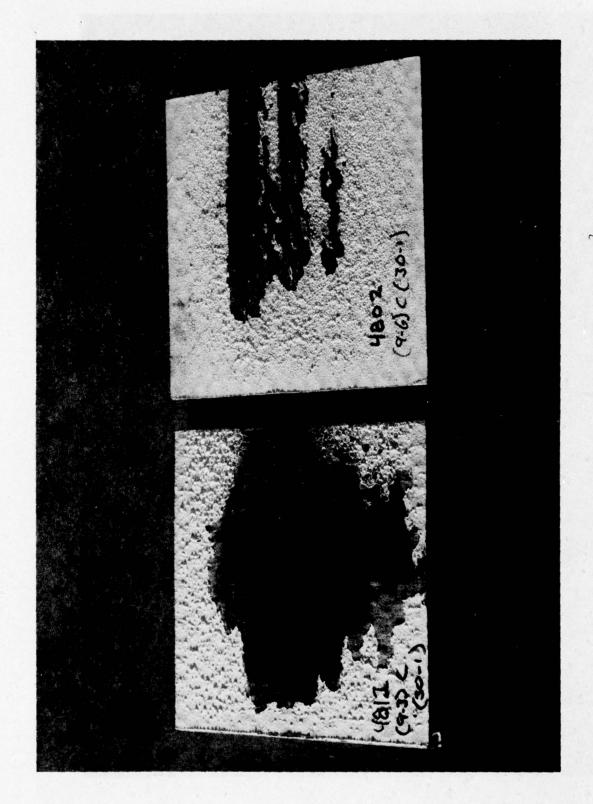
Figure 25. System 9 - 3- vs 6-ply specimen at 30 cal/cm² (one flash).
